Bridging the Gap: Lessons Learned from the Jenelata Bridge Collapse and Future Restoration Plans

The collapse of the Jenelata Bridge underscores the vulnerability of bridge infrastructure in areas with significant hydraulic forces. This study investigates the primary causes of the bridge's collapse and proposes a restoration approach to prevent similar incidents in the future. The findings reveal that intense scouring around the foundation, exacerbated by the bridge's proximity to a river meander, weakened the abutment structure. The foundation's design, which used shallow footings instead of more suitable deep foundations, was found inadequate to withstand the hydraulic pressures, resulting in instability and eventual structural failure. Notably, simulation analysis confirmed that the bridge itself was structurally sound to support traffic loads, ruling out overloading as a collapse factor.

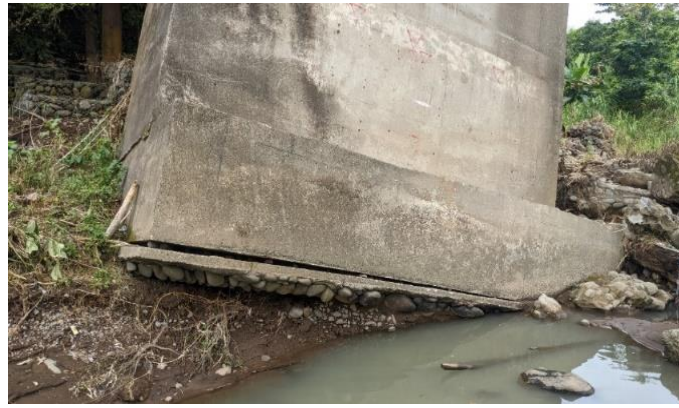
Picture 4. Abutment of Jenelata Bridge

Observational data from the site, including geotechnical surveys, provided direct evidence of structural degradation at the abutments due to severe scouring. Hypothesis testing at this stage confirmed that the local scouring depths exceeded foundation tolerance, weakening the abutments over time. This scouring-induced deterioration led to tilting of the abutments, further compromising the foundation's stability and supporting the hypothesis that the abutments failed due to progressive, localized erosion forces. This degradation was visible from field data and photographic documentation, linking it to the bridge's structural vulnerability in the face of natural erosion dynamics.

2. **Abutment Relocation:** The second recommendation involves relocating one of the damaged abutments to a safer position, at least 20 meters away from the scoured area. This will mitigate the risk of further damage from erosion and enhance the stability of the abutment by moving it away from high-risk areas.
