## Design of Protective Structures to Anticipate Flood-Induced Damage to the *Jenelata* Bridge Abutment

### ABSTRACT

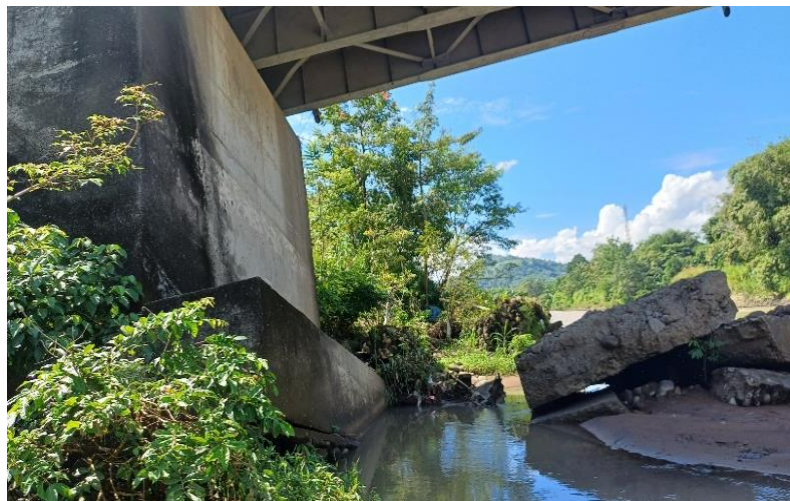
**Figure 2. Damage to *Jenelata* Bridge**

Field observations show that there is 50 m of erosion on the outer side of the river bend upstream of the bridge, which has worsened due to the absence of protective structures. These structures were eroded during the major floods in 2019. Information from BBWS Pompengan *Jeneberang* on the 2019 flood shows a discharge of 1,200 m<sup>3</sup>/s with a water level rise of up to 14 m. The flood caused erosion around the bridge pillars, with an estimated depth of 1.98 m from the foundation depth of 1.5 m. Based on the analysis results, it was also found that Q25 (680.79 m<sup>3</sup>/s), Q50 (855.53 m<sup>3</sup>/s), and Q100 (1,058.17 m<sup>3</sup>/s) also pose a serious threat to the stability of the foundation due to the protective structure and reduced bearing capacity.

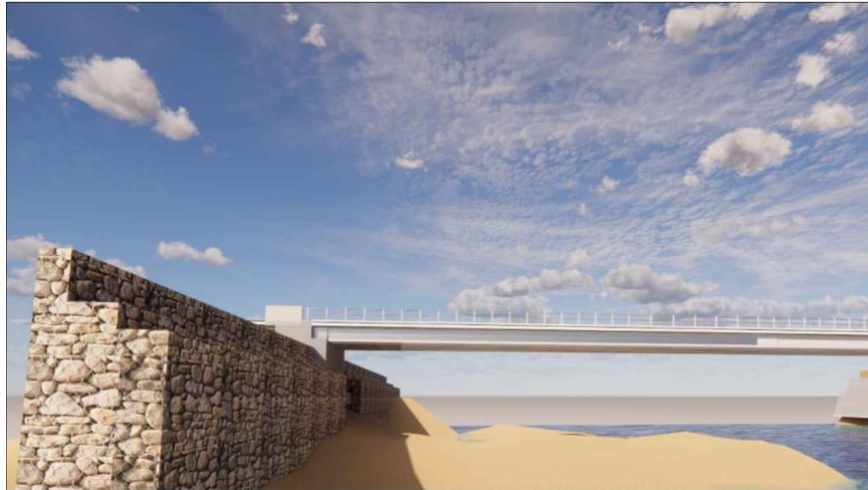
**Figure 3. Design of Protective Structure**

The image shows an example of the application of type C gabions ( $4 \times 1 \times 1$  m) on the riverbank near the bridge abutment. The gabions are made of galvanized steel wire mesh filled with stones and function as a protective wall against erosion and hydraulic forces. With a total length of 100 meters consisting of 50 meters upstream and 50 meters downstream this structure is expected to provide continuous protection to the most vulnerable parts of the river. Its presence is important to ensure that the bridge remains functional, even when the river experiences high discharge during the rainy season.

The protective structure planned for the *Jenelata* Bridge uses 4 × 1 × 1 meter type C gabions. The total length of the installation is 100 meters, divided into 50 meters on the upstream side and 50 meters on the downstream side, precisely at the outer bend of the river that is often eroded by the current. The selection of this type of structure is not without reason, as gabions are known to be flexible, easily adaptable to ground movement, and capable of reducing hydrostatic pressure thanks to the permeable nature of their stone composition. In addition, the gaps between the stones serve as flow energy dampers, reducing the speed of the current around the cliffs, while providing more durable protection against erosion.
